2012 Lytle Creek Watershed Illicit Discharge Detection Elimination

October 22-24, 2012

Including Town Creek, and Spring Branch

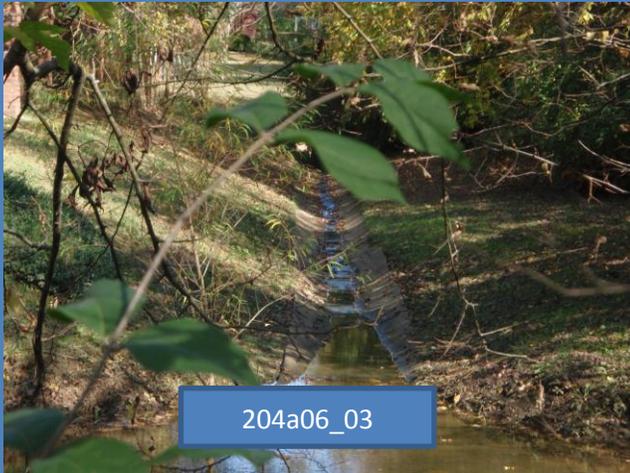
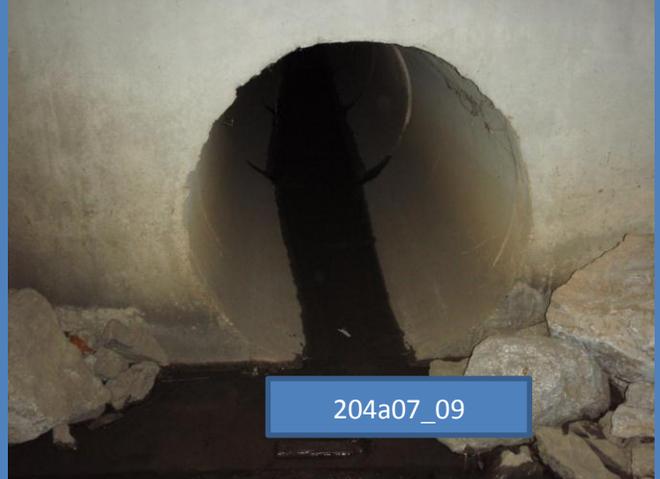
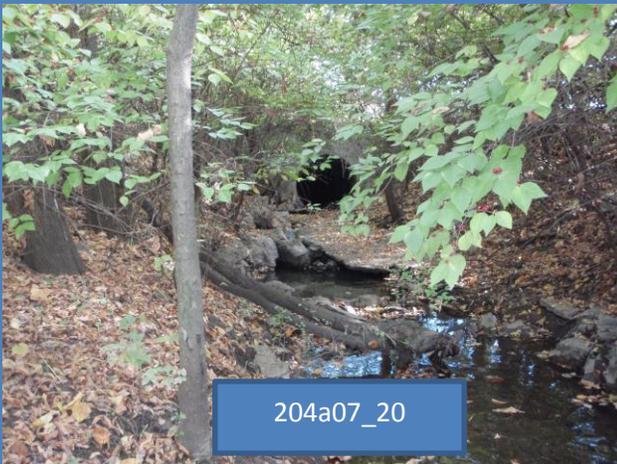
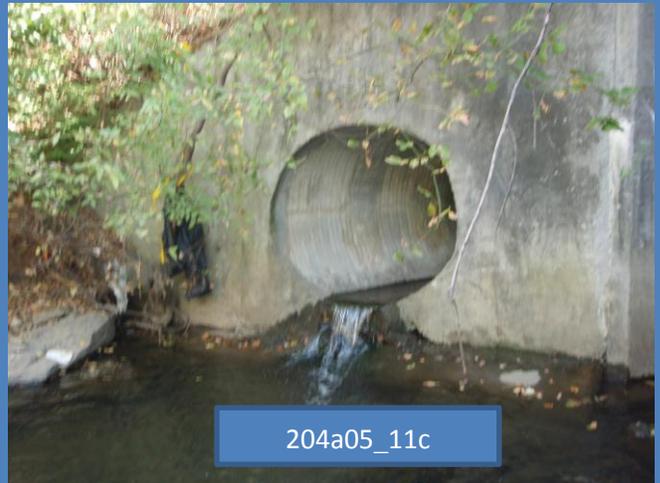
Outfall ID	Flow Type	Investigation
204a06_03	light	Seep comes up in concrete swale
204a07_09	light	Possible water leak .05mg/l
204a07_20	light	Draining wetland
204a05_11C	heavy	Possible spring
204a05_08	Light flow	Possible spring
